## Filter and dryers system converts biosolids to marketable end product

## System lowers the costs of managing biosolids on Navy base

## Bar screens keep large solids out of treatment plant

## Conversion of suction-tube-type clarifiers to spiral-blade clarifiers rectifies clogging and seal issues

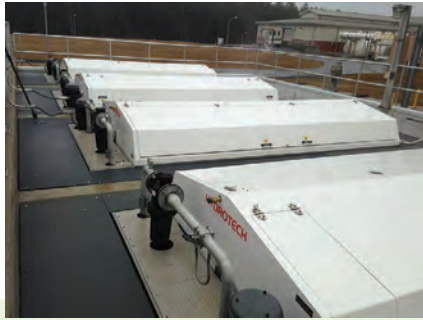
Plant personnel chose an advanced five-stage biological treatment process for biological removal of nitrogen and phosphorus, followed by secondary clarifiers. The clarified effluent flows by gravity to eight **HSF2220-2F Hydrotech Discfilters** from **Kruger USA**, followed by UV disinfection. Biosolids are dewatered with belt filter presses and dried with BioCon dryers. The Class A product is sold and transported off site by a nutrient management company and applied as an agricultural soil amendment.

The Hydrotech Discfilters treat 15.3 mgd average and 47.5 mgd peak flows. Two wet biosolids cake silos, two BioCon dryers, a dry-product handling and storage process including a pelletizing and screening system, and an inert gas and dust collection system complete the process. The two-dryer system is designed for a build-out capacity of 14 dry tons per day. The dryers minimize the amount of biosolids handled and provide a desirable and marketable product. **919/677-8310; www.krugersusa.com.**

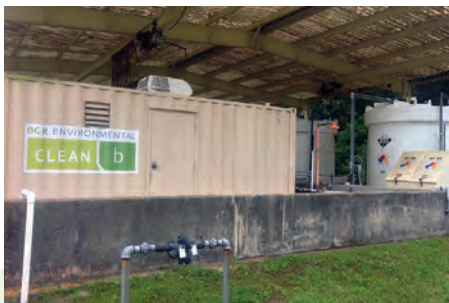
The base hired **NuTerra Management** to implement its **CleanB system** into the wastewater treatment plant. A unit was installed to treat waste activated sludge to Class B standards before dewatering.

The project substantially reduced energy consumption and lowered overall biosolids costs by eliminating aerobic digestion. The solution produced Class B biosolids suitable for land application. **904/819-9170; www.nuterra.green.**

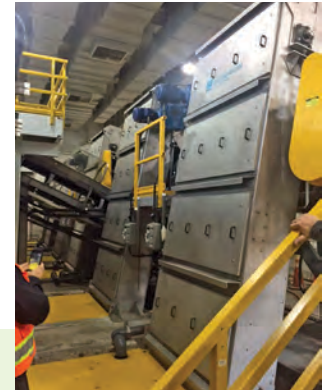
King County and design engineer CDM Smith decided on **ProTech-tor Multi-Rake Bar Screens** from **Kusters Water** with 6 mm and 10 mm bar spacing due to their reliability, low maintenance, and easy-cleaning bar rack. The screens include multiple rakes typically spaced on 5-foot centers that clean the bar rack every five seconds at the highest speed setting. This increased cleaning frequency is advantageous, particularly under higher flow conditions. If there is damage to the bar rack, each individual bar can be quickly and easily replaced by maintenance personnel with simple hand tools.

The screens were placed into service in the summer of 2014, and plant operators have indicated improved screening removal efficiencies, as well as improved performance of downstream processes. **800/264-7005; www.kusterswater.com.**

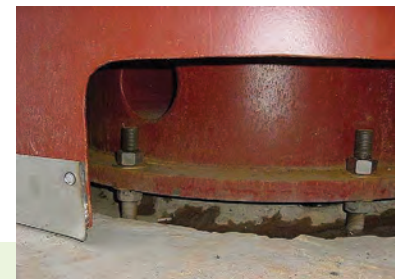
**Ovivo USA's Clarifier Rebuild Group** replaced the clarifier components with new-style spiral-blade clarifier systems using a center manifold device (CMD). The existing tank's piping used the typical centrally and concentrically located return activated sludge (RAS) pipe within center support/influent columns. The CMD allows the sludge collected by the spiral blades to be withdrawn through the existing under-tank RAS piping without modification.

The project saved the expense of digging into the reinforced concrete of the tank bottom to relocate the RAS collection port and its connection to the existing piping layout. The clarifiers have been reliable and consistently perform better than the original units. Since no tank modifications were required, the clarifiers could be converted to the new-style mechanisms without any construction delays for under-tank piping changes. **512/834-6000; www.ovivowater.com.**
